# The earthquake damage and reinforced method of combined water tank

Huang Yu-Tang<sup>1</sup>, Chang Min-Li<sup>2</sup>, Wu Jing-Wen<sup>3</sup>

Forth Branch, Taiwan Water Corporation, Junior Engineer<sup>1</sup>, Section Manager<sup>2</sup>,  
Deputy Manager<sup>3</sup>

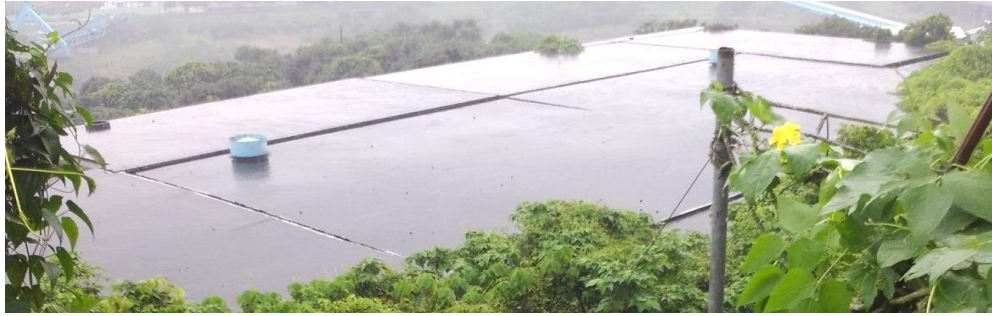
Figure 1 The roof of water tank – the failure of extension joint by expansion

The damaged extension joints can be dealt by removing the exterior of 60 cm, re-placing the waterproof material, re-smearing silicon that is elastic and waterproof, placing three layers of glass fabrics, smearing silicon again, placing the rubber mat, placing stainless steel plate and then fixing the stainless steel plates with expansion screws.

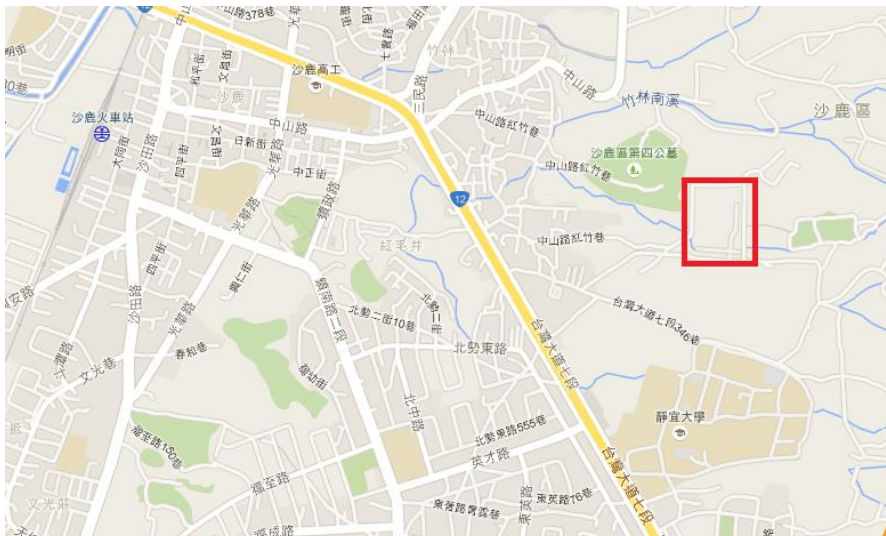
At present, the reservoir is located nearby the forth public cemetery and Providence University in Shalu Dist., Taichung City. It is away from the Tuntzuchio fault approximately 2.623 KM, which was constructed in 1990 (The project of water distribution center in the specific district of Taichung Harbor). The overall sizes are 108M of length, 64M of width, 6.4M of height, about 0.8M of foundation depth, and the storage capacity is about 40,000 tons. The structure got slightly deformation and leakage, showing as figure 2.

Figure 2 the nearby of water tank

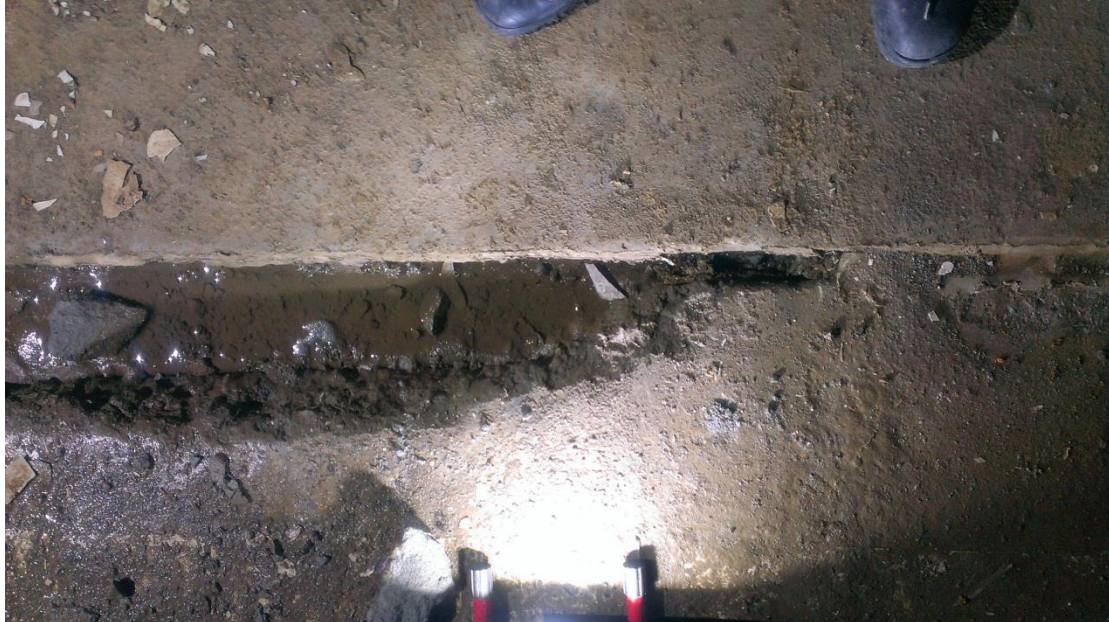
The common usage impairment is the crack of walls and plate that is caused by interactional collision, or tear impairment of extension joint caused by large displacement, showing by figure 3, figure 4 and figure 5. Moreover the combined water tank was built in early years. And the early building code which is lenient on the capacity of earthquake resistance, the joints of beam and column usually got cracking after the earthquake, showing by figure 6.

Figure 3 The crack caused by interactional bump of base plate of water tank

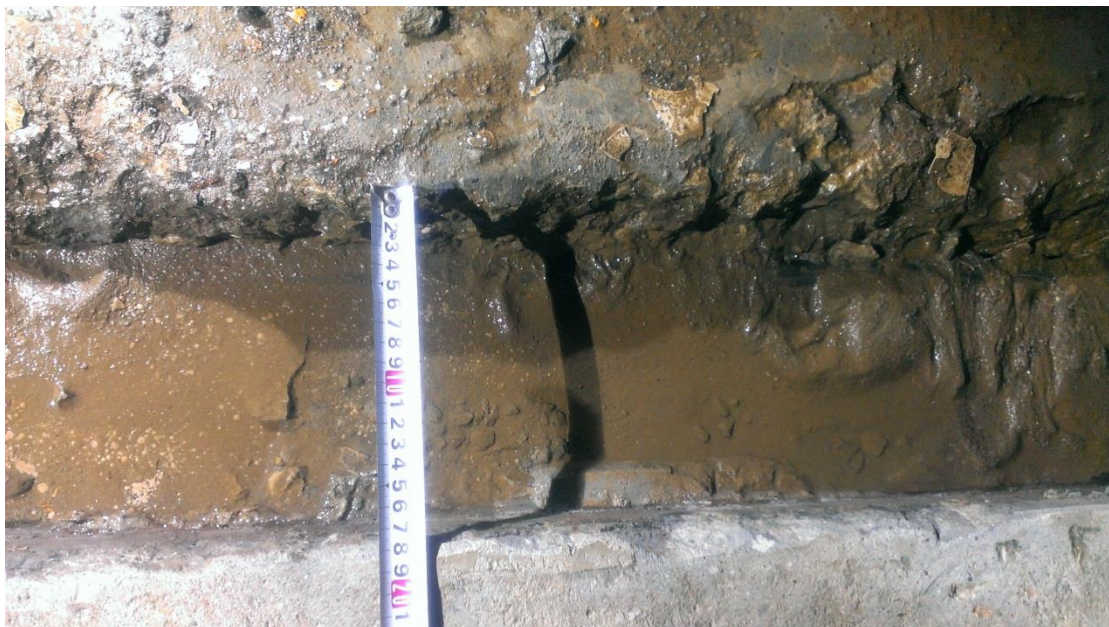
Figure 4 The expansion of the extension joint

Because of the combined feature of these combined water tank, every independent structure system of unit water tank will vibrate separately during the earthquake. The corner, side and internal part was damaged by strike of the interactional displacement. That causes the severe damage of extension joints.

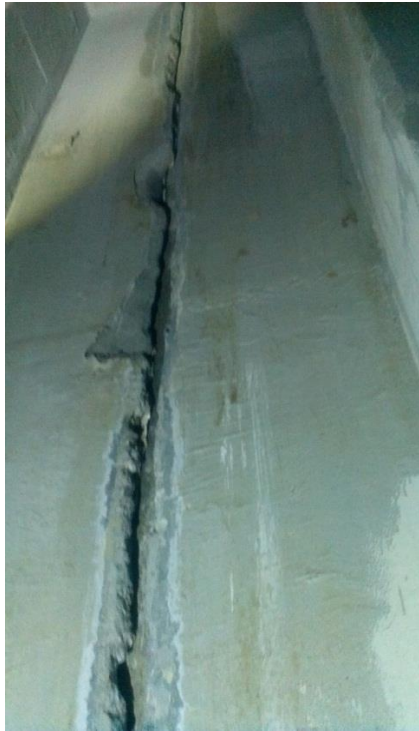
Figure 5 the crack of wall

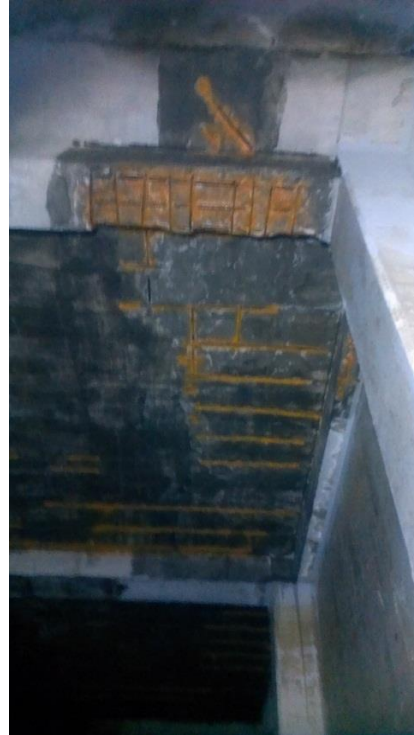
Figure 6 the crack of the joint of beam and column

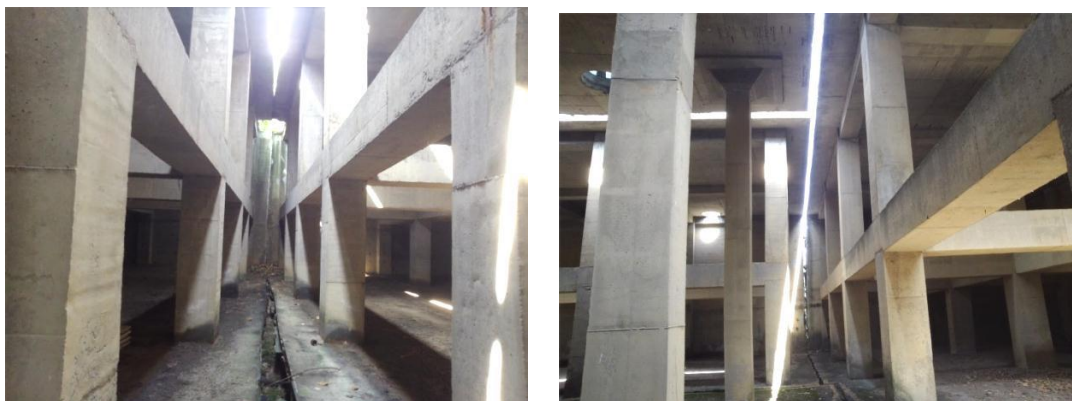
The water tank was built in 1990, the water tank combined by 16 rectangular water tank and 4 irregular water tank. Each water tank was connected by extension joint. There is a similar water tank which is located at Taichung. The water tank had got extremely severe damaged by the over expansion of extension joints in earthquake duration. It caused the fundamental losing and storage function losing, showing by figure 7. Therefore this tank we discuss here didn't apply connection of improving earthquake capability. It may also face the same situation which the large expansion displacement causes the storage capability losing after a massive earthquake.

Figure 7 The severe expansion of extension joint
