The Damage Analysis of Distribution Pipes in Artificial Ground

Shu Kikuchi¹⁾, Keita Obonai²⁾,
Shinji Ogata³⁾, Nobuhiko Inoue⁴⁾, Tomoo Miyano⁵⁾

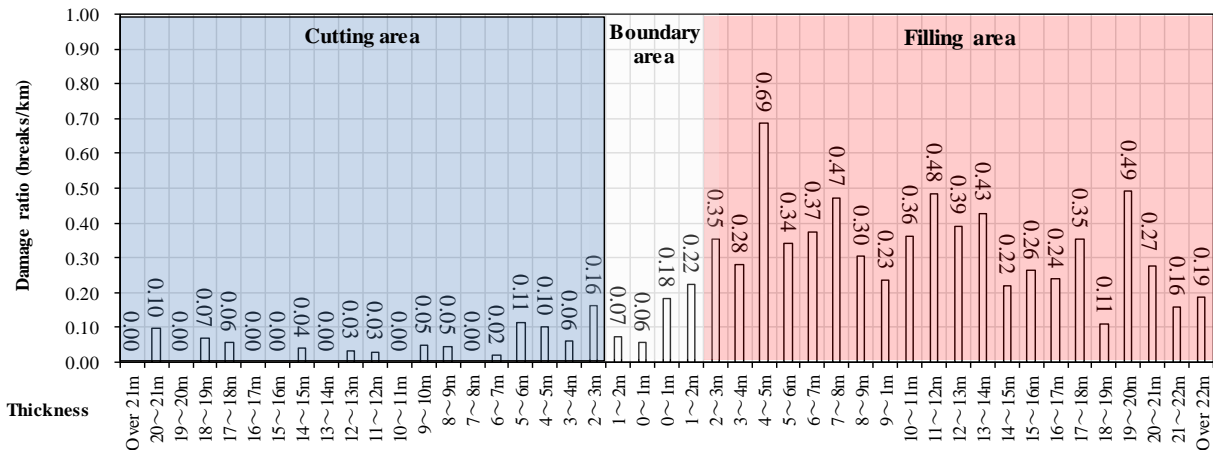
Figure 4 Damage ratio by the thickness of cutting and filling

Table 5 and Figure 4 show the damage ratio for distribution pipes in cutting, boundary and filling area. The damage ratio is 0.05 in cutting area, 0.13 in boundary area, and 0.36 in filling area respectively. When an earthquake happens, it is presumed that distribution pipelines are influenced by ground damage and broken mainly between cutting and filling area in artificial ground. It is so called the boundary area. However, this study shows a tendency that high damage ratio is cutting, boundary, and filling area in that order. Damage ratio in boundary area and filling area are 2.6 times and 7 times higher than that of in cutting area. Also it shows that the damage ratio in filling area is wholly high, and the highest damage ratio of the filling area is the thickness from 4 to 5 meter. This result shows that the damage to water pipelines varies to subsurface ground conditions even if the same shake happened in developed land. This result implies that filling area is affected with a shake relatively and pipelines installed in filling area were easy to break.

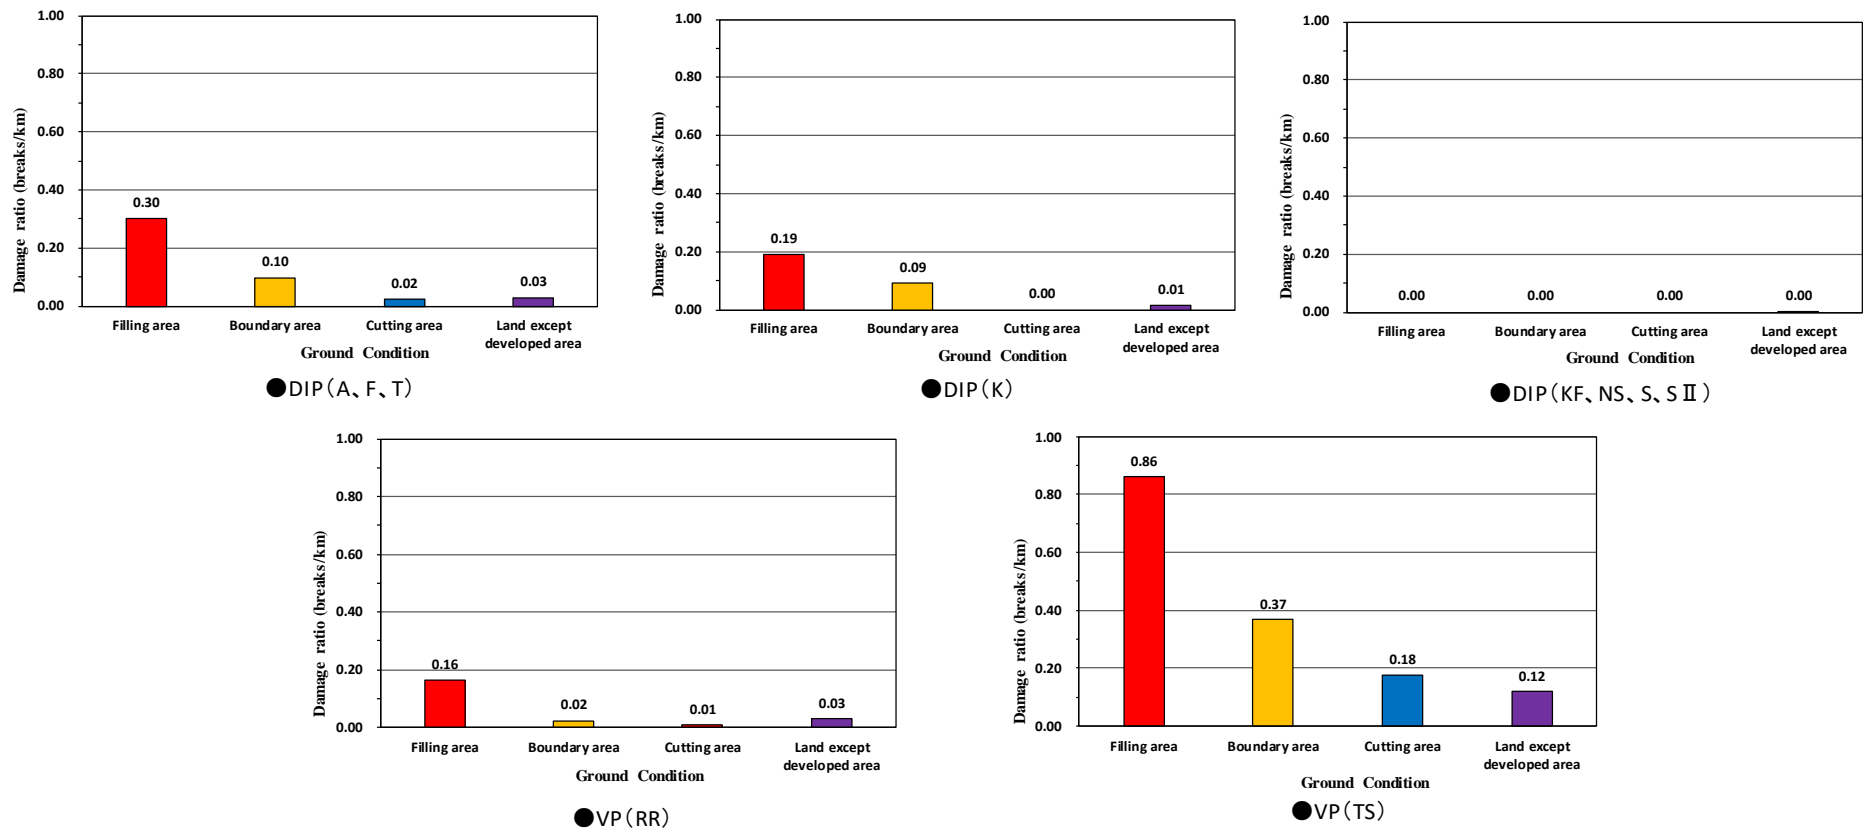
Figure 5 Damage ratio for pipelines per ground condition by pipe materials and joints.

Figure 5 shows the damage ratio for pipelines each subsurface ground condition to different pipe materials and joints. Most pipe materials and joints have a tendency that damage ratio becomes higher in order of cutting, boundary, and filling area. Damage ratio of DIP (A, F, T) and VP (TS) are higher than that of the others. As a result, it is suspected that these pipes don't have earthquake resistant performance like DIP (KF, NS, S, S II) . In addition, the material of VP (TS) is less stronger than the others, so the damage ratio of VP (TS) is the highest. Therefore, it implies that DIP (A, F, T) and VP (TS) installed in filling area have high priority to be replaced by earthquake resistant pipe.

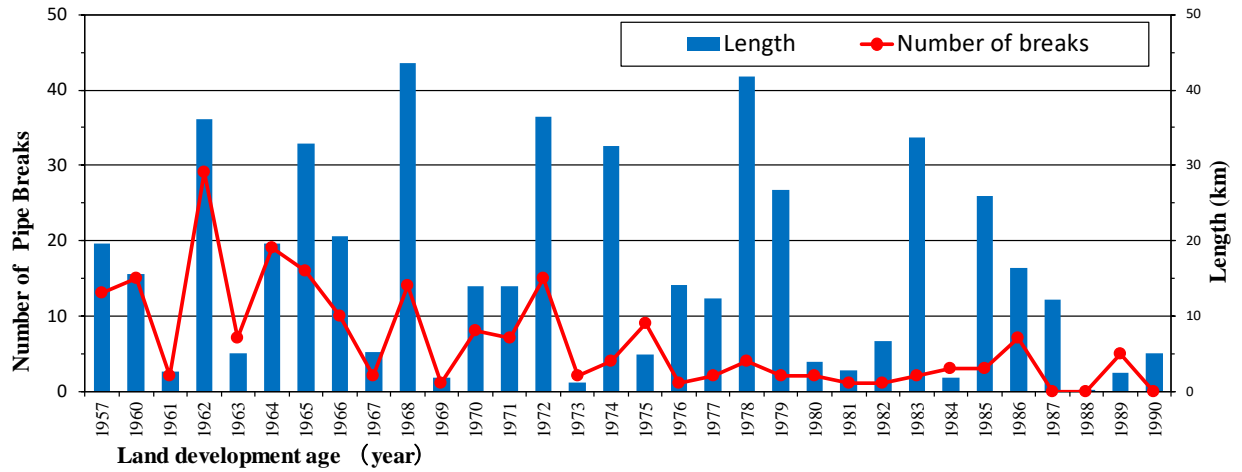
Figure 6 Number of Pipe Breaks and Length in filling area

Figure 6 shows number of pipe breaks and length of pipeline and Figure 7 shows the damage ratio in filling area according to land development age. The damage ratio in filling area is approximately 0.9 (breaks/km) before 1965, it is approximately 0.4 after 1965. Damaged water pipe installed in filling area was not found after 1990. It makes a clear tendency that pipes have lower damage ratio according to land development age. In 1965, Sendai city applied an Act on Regulation of Residential Land Development, the act decides technical standard for the construction. This suggests that strength of subsurface ground condition become higher after 1965, and also the figure shows there are few number of pipe breaks. Therefore, it is necessary to pay full attention to the pipes installed in filling area that developed for the past several years ago. Also, it implies that pipes installed in filling area have high priority to be replaced by earthquake resistant pipe.

• After 1990, damaged pipeline was not found in filling area.
