The Damage Analysis of Distribution Pipes in Artificial Ground

Shu Kikuchi¹⁾, Keita Obonai²⁾,
Shinji Ogata³⁾, Nobuhiko Inoue⁴⁾, Tomoo Miyano⁵⁾

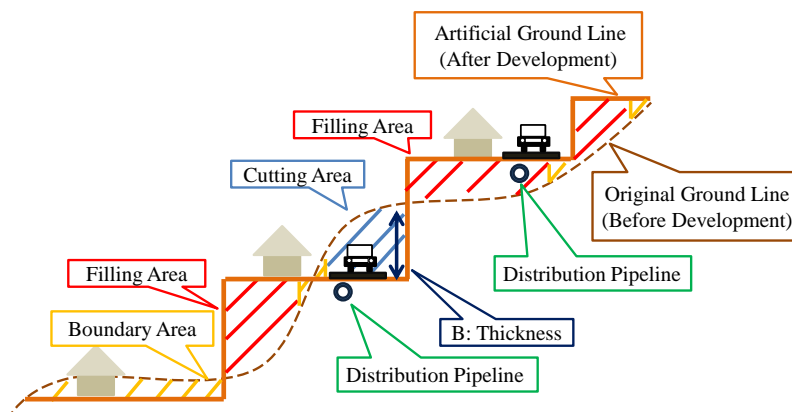
Figure 2 Cross Section before and after land development

Figure 2 shows cross section before and after land development, we classify ground condition into filling, cutting and boundary area by the thickness such as this figure. And we make a grand topography of developed residential land by the thickness as reduced scale about 1/2,500 (Figure 3).
